Arlington Reservoir Master Plan

2018

INTRODUCTION AND EXECUTIVE SUMMARY

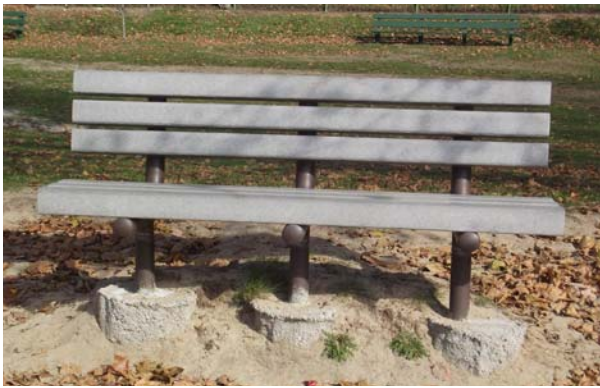
Typical bench condition

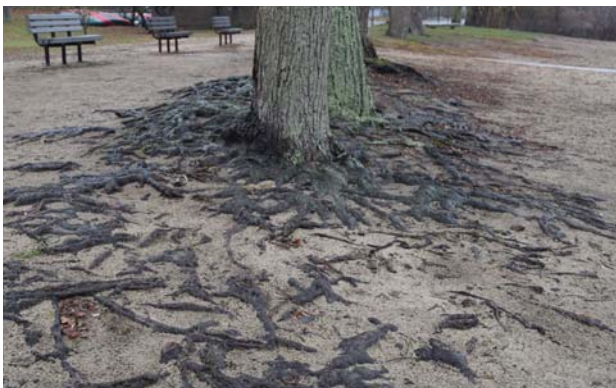
Exposed roots within sandy beach

respite from the bright sun during the hot days of summer. Constant sand and soil erosion around these trees, however, has resulted in exposure of the root systems, thus compromising their future viability. Additionally, the roots can pose a tripping hazard.

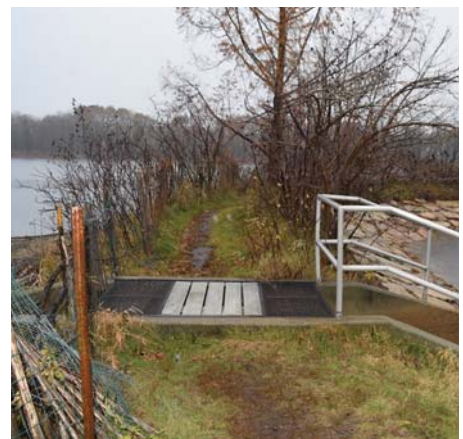
The swimming area is impounded on three sides by an earthen berm that rises approximately three feet out of the water and tapers back to the water at a 3:1 slope. It is armored on both sides by stone riprap. This berm is interrupted by a sluice gate and concrete spillway on its southern end, which provides the only water flow connection between the swimming area and the rest of the reservoir. An informal walking trail runs along the top of the berm. The trail is overgrown with vegetation, making it barely three feet wide. The surface is very uneven due to tree roots, animal burrows and erosion. The filtered swimming water is fed by a series of inlets spaced evenly north to south along the deepest part of the swimming area. Water is also delivered through a fountain found in the north end of the swimming area.

Sluice gate and concrete spillway; pathway around the berm beyond

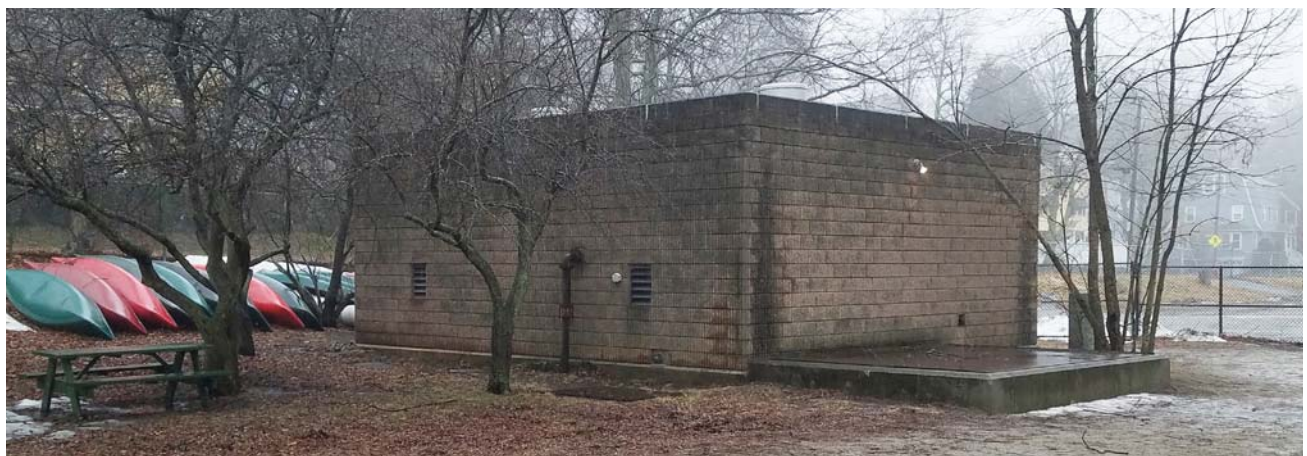
The water filtration building is a one-story, 800-square-foot seasonal structure constructed in 1982. Existing drawings by Environmental Design & Planning dated April 1982 are available for review in Appendix K. Overall, the building is in fair condition, but in need of general repairs, upgrades and maintenance. Specific observations are as follows:

North and west elevation of the pump house

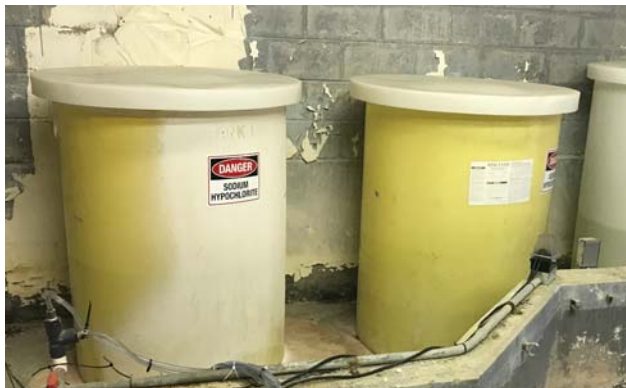
- The filter sand has not been changed in over ten years. The vessel is rusted. Operation has not been able to properly backwash the vessel and it is unknown how much sand is still in the filter.
- The pump is currently a vertically-mounted pump, however, it is a flood suction pump that is above the static water level, which makes it challenging to prime.
- The chemical controller no longer works and it doesn't appear to have worked for years.
- Instrumentation, such as flow meters and pressure gauges, do not function properly.
- The chemical injection system is not interlocked with the pump.
- The Town uses domestic water to supplement filling the swimming area when the water is too low.
- Site valves either do not open and operate or are difficult to operate.

Chlorine Disinfectant Holding Tanks

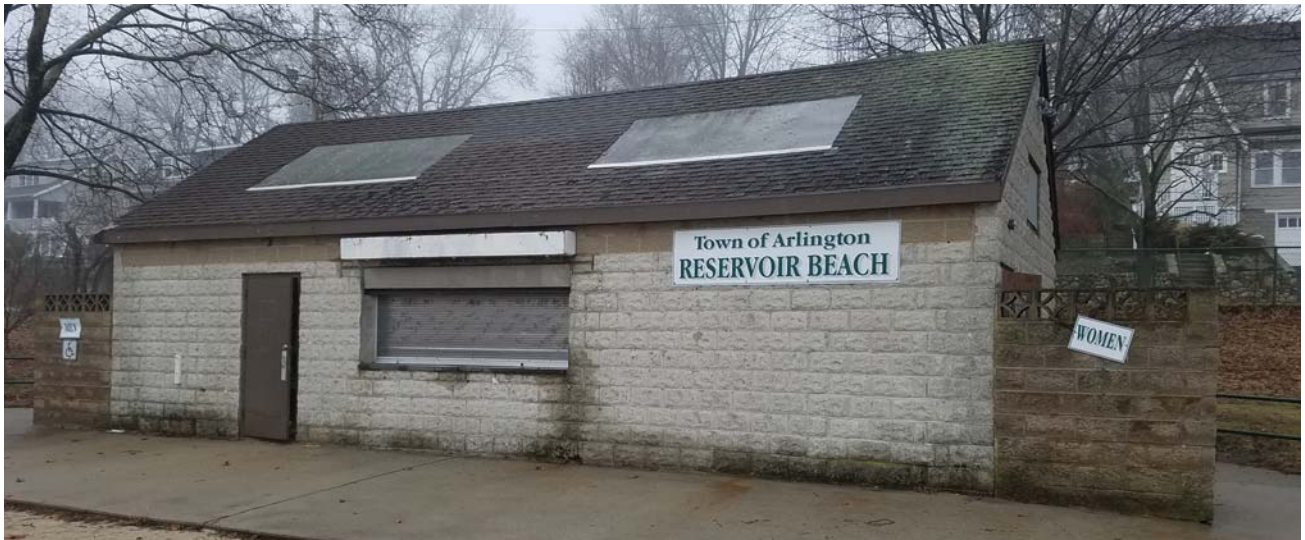
This park building is a one-story 800-square foot seasonal structure renovated in 1982. The original construction date is unknown. There are concrete masonry screen walls at the restroom doors. Overall, the building is in fair condition, but it is in need of general repairs, upgrades, accessibility improvements and maintenance. Specific observations are included on the following pages.

West elevation of the Bathhouse and Concession building

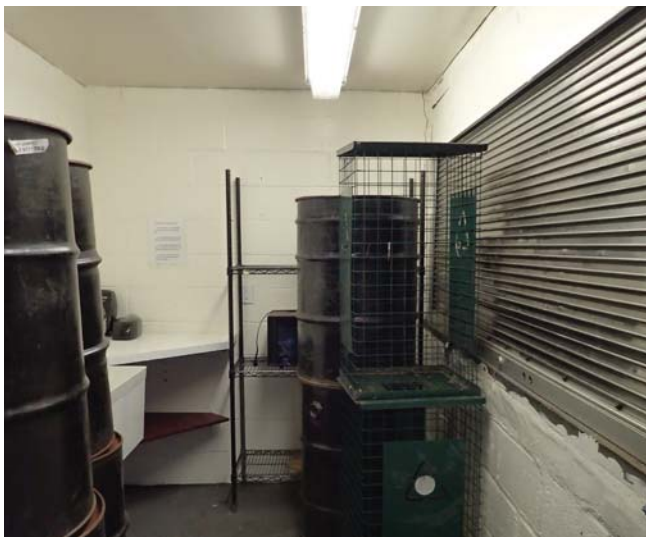
Floor and walls inside the concession area

Floor - The interior floor is cast-in-place concrete with a painted finish. Its condition appears to be good, with no observed cracking or displacement. It is assumed that there is no thermal insulation or vapor barrier in the floor construction, and that thermal bridging exists around the floor slab perimeter. This is not problematic for a warm-season-only building.

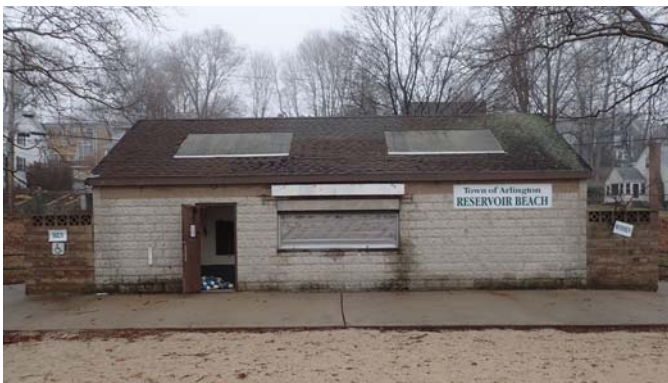
Openings - There are translucent skylighting panels in two locations at the west slope of the roof, providing daylight to the Men's and Women's rooms. These panels are installed as part of the shingle roof system, and are not separate skylights as such. There are significant leaks at the lower edges of these panels. There is a single service window at the west wall, which is protected by a roll-up metal shutter. The condition and operation of the shutter was not verified, but it appears to be in serviceable condition. The service window is not accessible, as discussed below.

West elevation of Concession and skylights

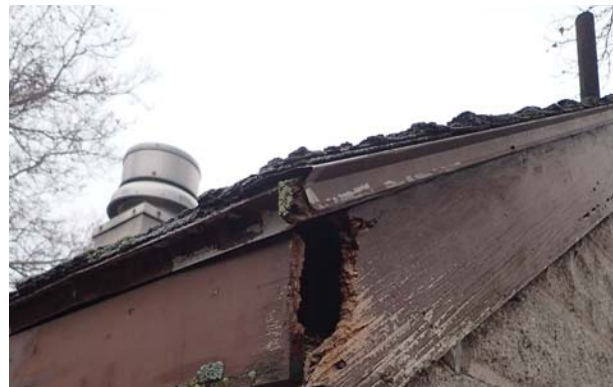
Wood fascia board in poor condition

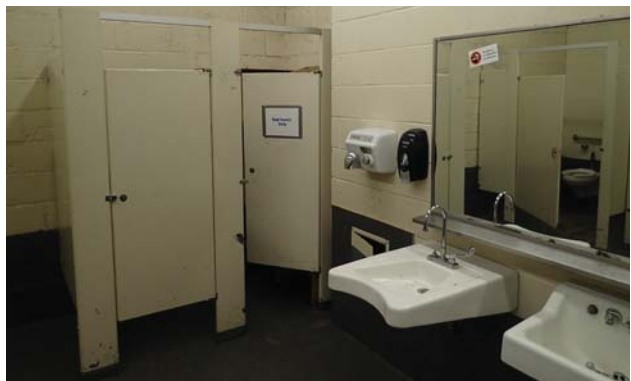
Women's room partitions and fixtures

Toilet Partitions & Accessories - Toilet partitions and accessories, including grab bars, mirrors, shelves, hand dryers, soap and toilet paper dispensers, etc., are in fair to good condition, but should be considered for replacement as part of an overall upgrade to the toilet rooms.

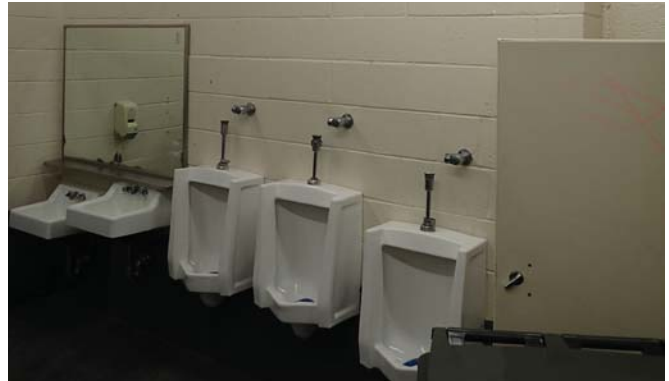
Men's room partitions and fixtures

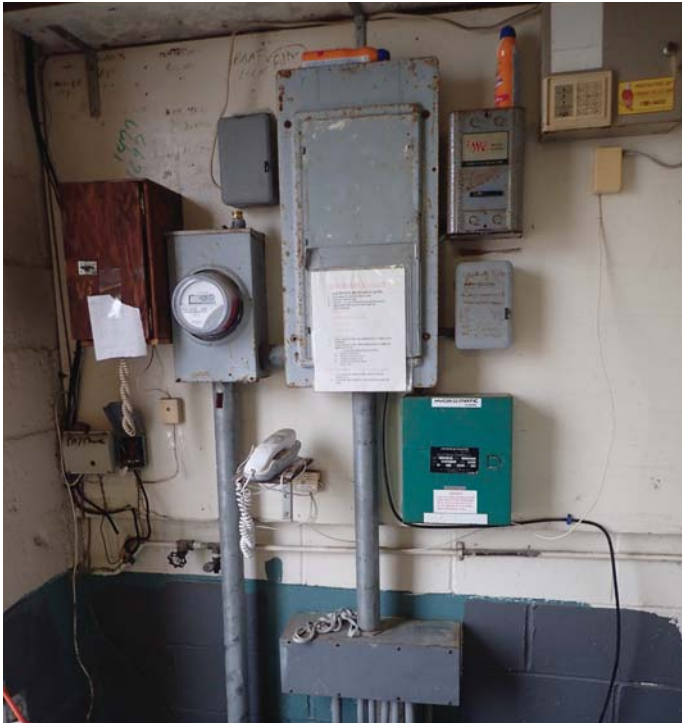
were not evaluated as part of this assessment. No known issues were reported. Interior lighting is by fluorescent tubes in moisture-resistant enclosures. Light levels in the Men's and Women's rooms were poor. Exterior lighting fixtures are outdated, but have been fitted with replacement LED bulbs.

Electrical system within the bathhouse & concession

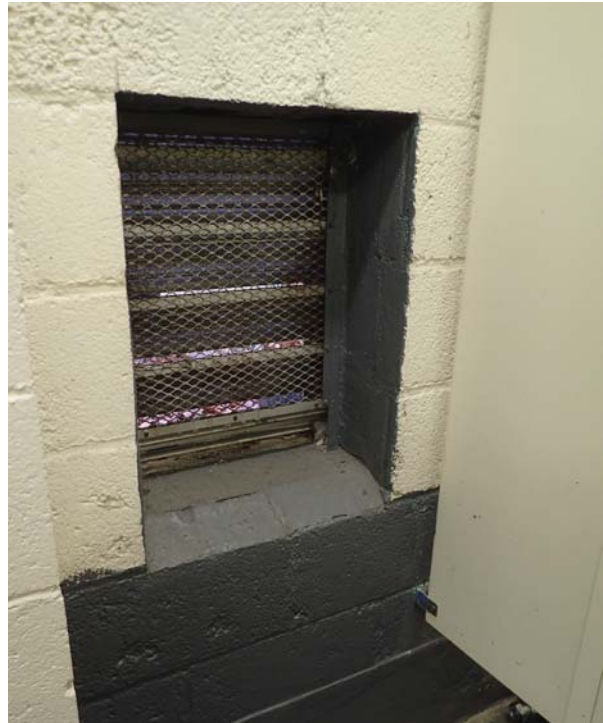
In terms of louvers, there are rectangular wooden gable vents at each end of the building, which were closed off with exterior plywood panels for the winter. These vents provide direct ventilation of the Men's and Women's rooms, in conjunction with roof-mounted exhaust fans. There are two aluminum louvers at the east wall, which appear to be in good condition. There is no mechanical equipment or dampers associated with these louvers, which only provide passive intake air into the Men's and Women's rooms.

Passive intake louvers within the bathrooms

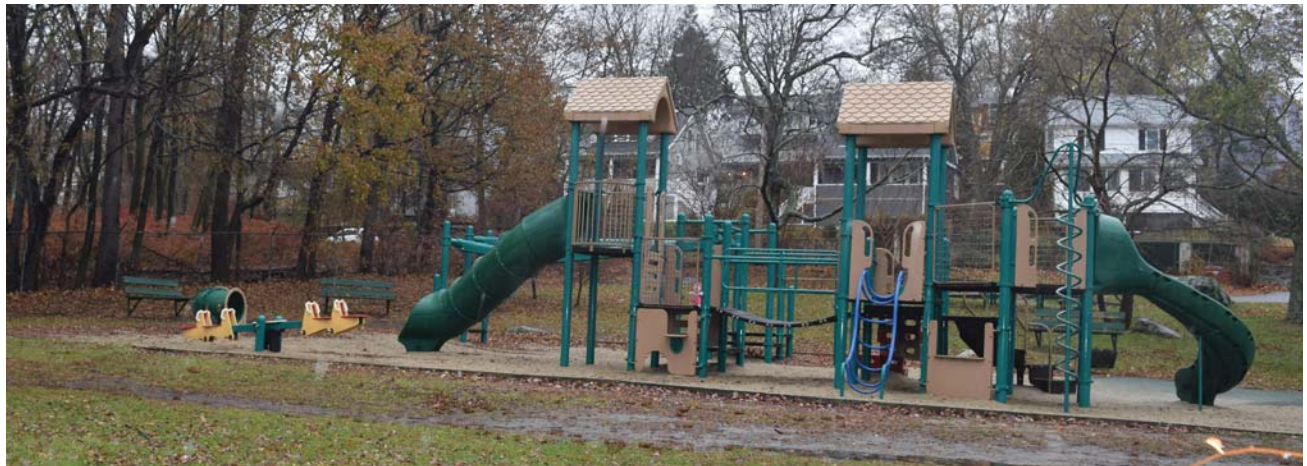
Large play structure

A small play area and individual play pieces are located within the limits of the bathing beach, which make them unavailable to the general public and neighborhood during beach season. The large play structure shown above serves children from ages 5 to 12 years old and offers multiple slides, a wobbly bridge, climbers, a zipline, and space for imaginative play. There is also a seesaw, a tunnel and benches included within this play zone. Although an accessible route is provided to this large play structure, the surfacing material is generally sand, which is not ADA-compliant. A 2-to-5 year play structure with a slide, a free-standing set of overhead bars and a swing set all sit within separate zones of sand and do not meet Certified Playground Safety Inspector (CPSI) standards. All of these structures are at least fifteen years old and have reached their maximum life expectancy.

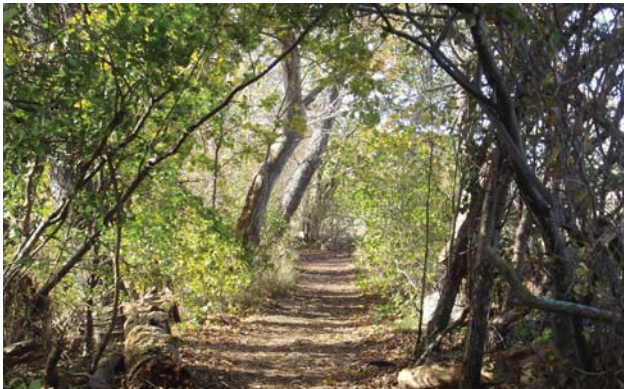
Trail condition next to Busa Farm

- The perimeter trail condition is wildly variable and lacks consistent accessibility. Trail improvements should address tree roots, ensure positive drainage away from the paths and establish a typical and consistent width along the entire trail.

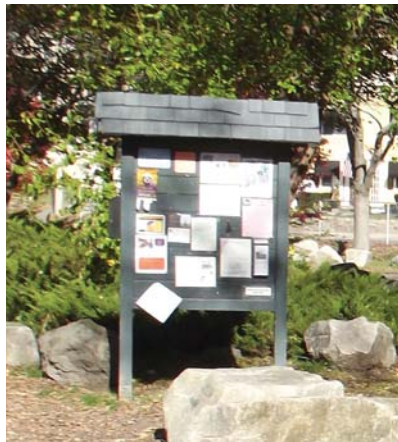
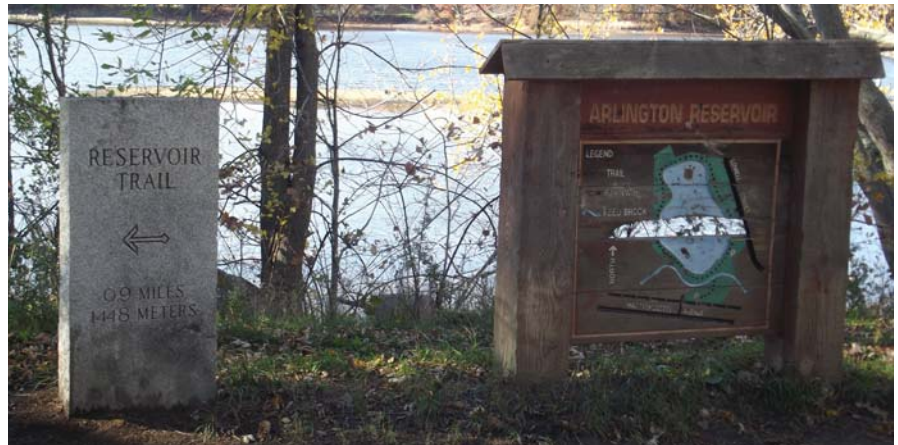
Community board/trail map kiosk

Granite mileage marker and deteriorated wooden kiosk

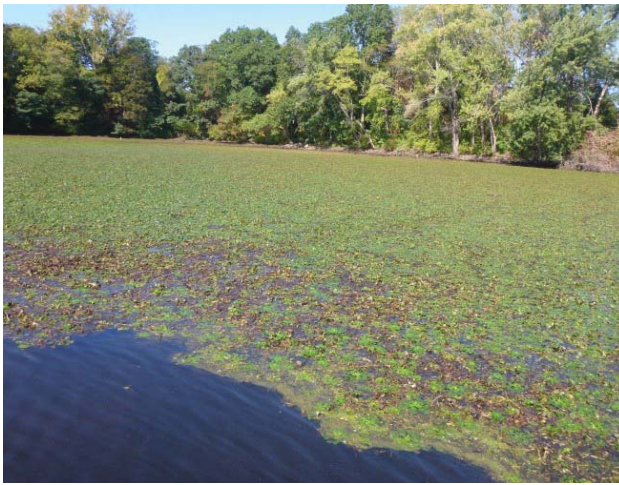
Aquatic Plant Community - The rooted plant community is a dominant feature of The Res and is comprised primarily with three species: water chestnut (*Trapa natans*), Eurasian watermilfoil (*Myriophyllum spicatum*), and coontail (*Ceratophyllum demersum*). The first two are invasive species, and although coontail is native, it has been known to reach nuisance densities. A few other species are present, either as sparse or moderate density growths, including spiny naiad (*Najas minor*), curly leaf pondweed (*Potamogeton crispus*), spiral pondweed (*Potamogeton spiralis*), burreed (*Sparganium* species), and aquatic clover (*Marsilea quadrifolia*). Both the spiny naiad and curly leaf pondweed are invasive species and, while aquatic clover is not native, it does not reach nuisance densities that would qualify it as an invasive species. The rooted plant community of The Res is half invasive species by taxonomic breakdown, but much more than half by biomass.

Water chestnut

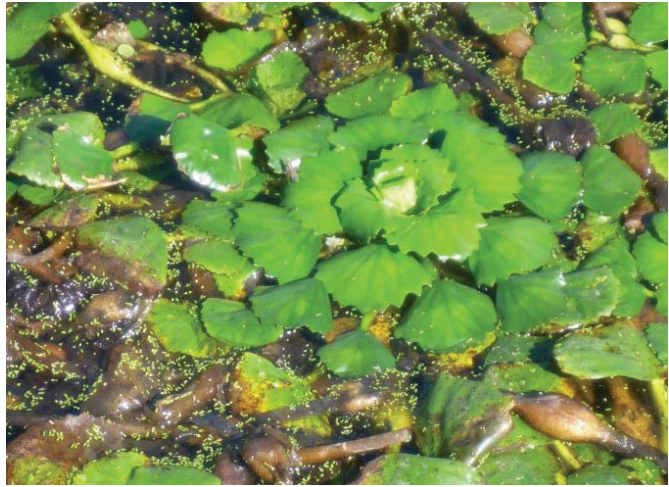
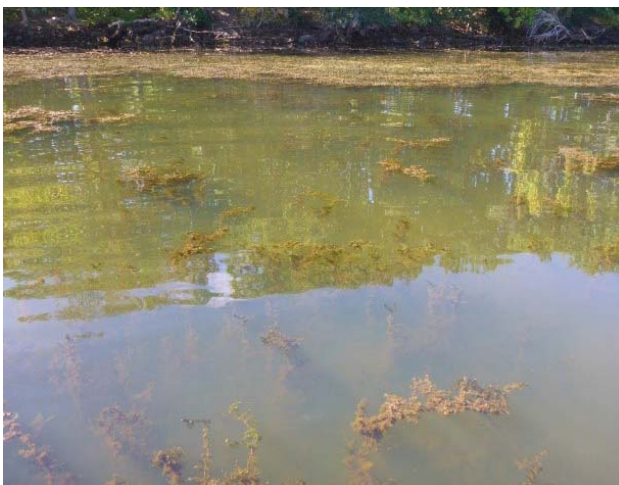
Eurasian Watermilfoil

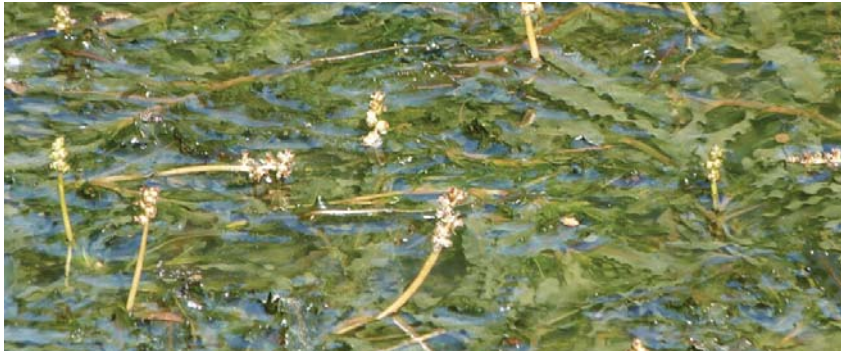
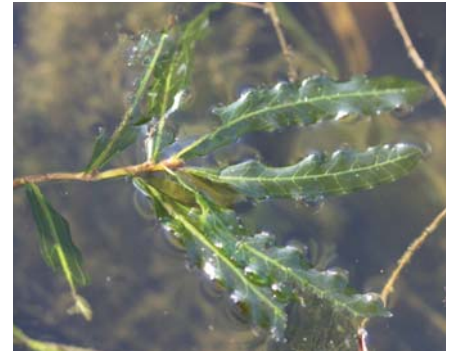
Given that this survey was conducted in late September, it is possible that other species were more abundant earlier in the growing season, most notably curly leaf pondweed, which tends to peak in late spring and die back over the summer. The Res has multiple plant problems that represent the most obvious threat to its designated uses. With a maximum depth of 7 feet, there is no place in the reservoir where plants cannot grow due to depth/light limitations. Only a few areas have coarser substrate that limits plant density. If not for the mechanical harvesting program, water chestnut

Curly leaf pondweed
